# Water valve

Part number: 1101100-F

Part of [EVO Cleaner assembly 2 - 1109502](#)

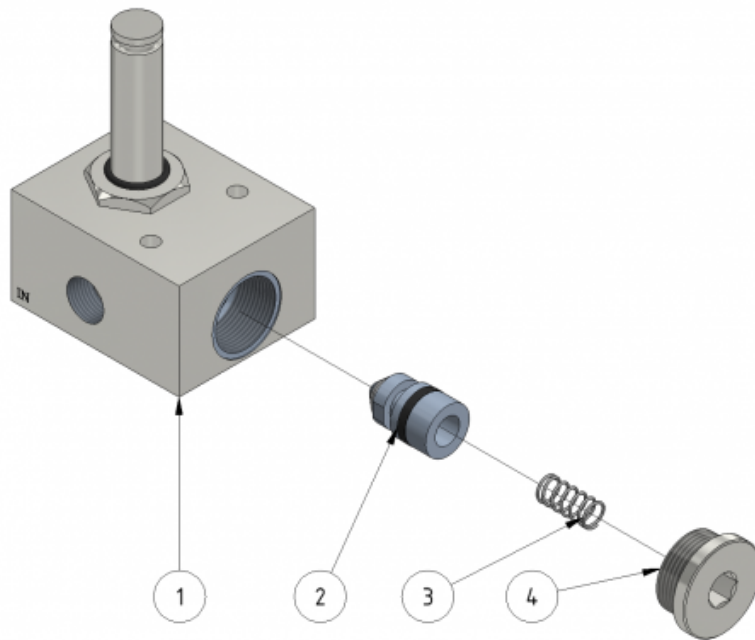
ITEM	DESCRIPTION	PART NUMBER	QTY
1	Magnetic valve	1101100	1
2	Plunge	969202	1
3	Spring	969203	1
4	Plug	969204	1

The water valve can get blocked/clogged with particles if the incoming water is dirty. Always use a [water filter](#) on the incoming water by the [high-pressure washer](#).
