Parked position - Tower

From:
https://wiki.envirologic.se/ - **Envirologic Support Wiki**

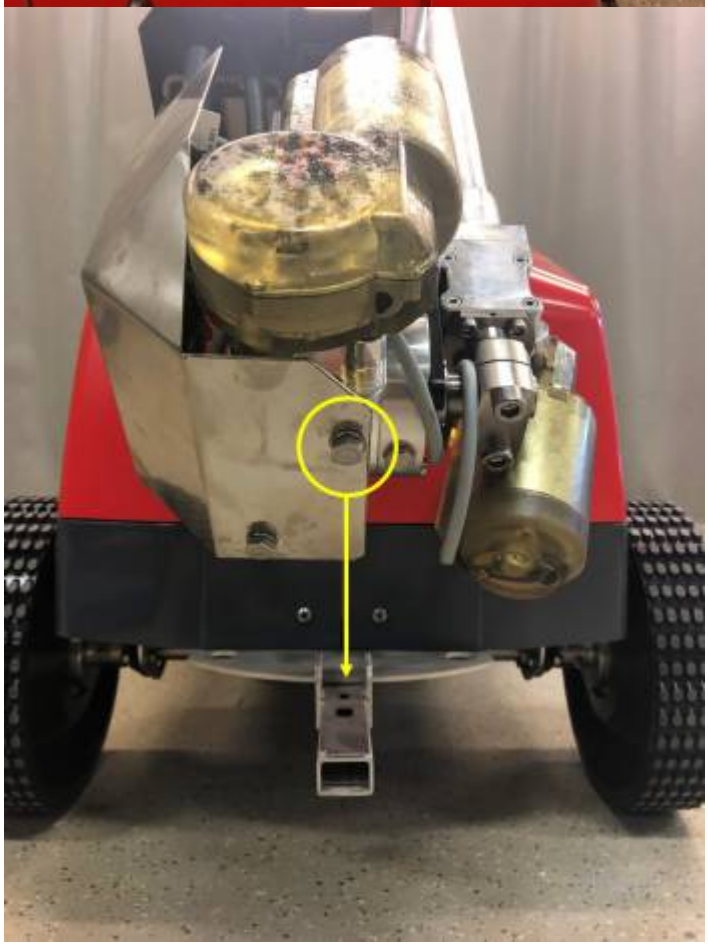
From production the robots physical position is lined up with the line on the hood. The right hand side of the boom lines up with the right line on the hood (seen from the display).

3. Track the right side of the boom (seen from the display) and see if this side follows the line on the hood (see picture). You can also take a look at the front. See if the marked bolt lines up with the rod.

4. If the position of the tower doesn't match up with the line on the hood, **contact us** so we can

change the parked position for the tower.
