Water valve

Part number: 1101100-M

Part of [EVO Cleaner assembly 2 - 1109502](#)

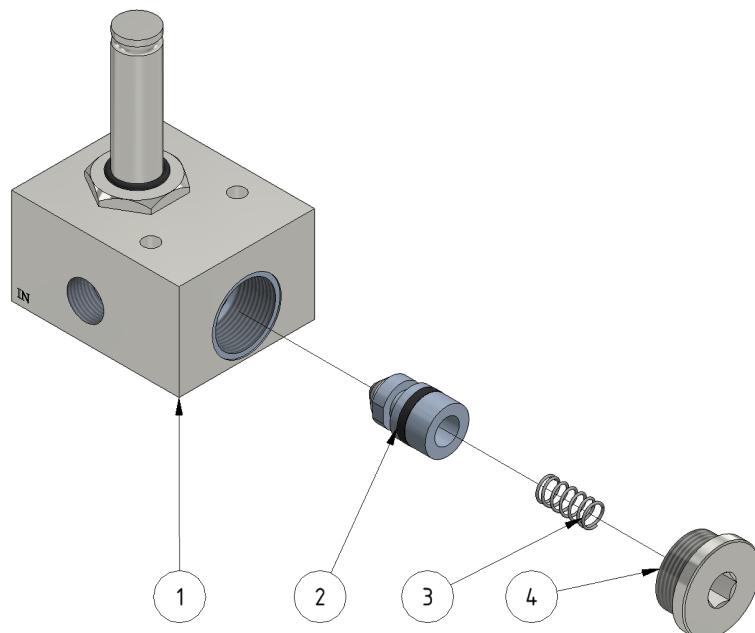
ITEM	DESCRIPTION	PART NUMBER	QTY
1	Magnetic valve	1101100	1
2	Plunge	969202	1
3	Spring	969203	1
4	Plug	969204	1

The water valve can get blocked/clogged with particles if the incoming water is dirty. Always use a [water filter](#) on the incoming water by the [high-pressure washer](#).
